Bulletin Number: 20112019

Date: November 27, 2019
Product: DCC(F) / DCB(F) Series - All Serial Numbers
From: Technical Service Department
Title: Gasket Removal Two-Pipe Venting

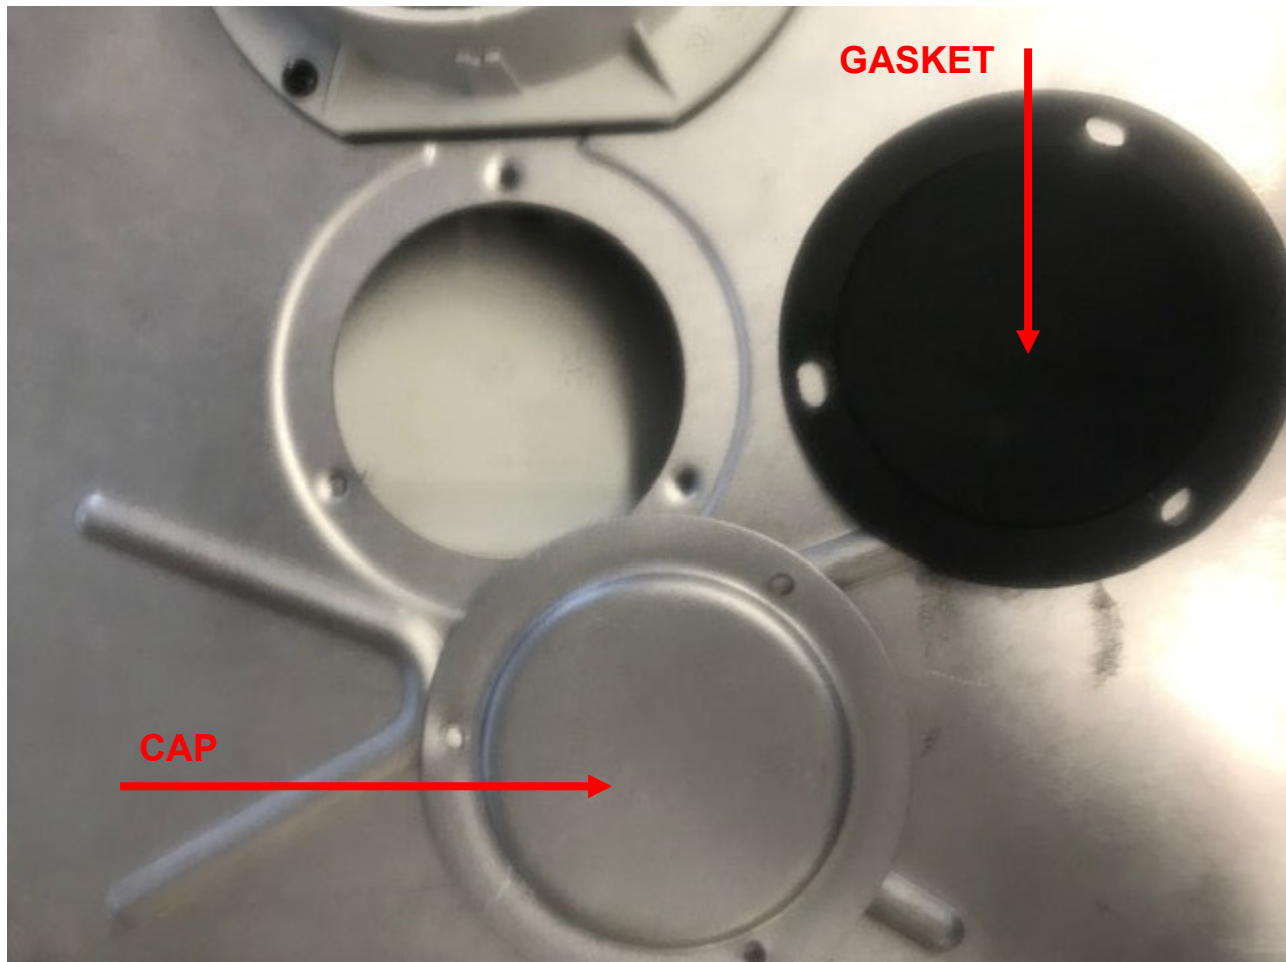
When converting from single-pipe venting to two-pipe venting, the cap and gasket must be removed. In some instances, it has been found that the cap was removed but the gasket was left in place. This can lead to the boiler displaying an Error Code 53.

ECR will be adding a label to remove the gasket when converting from single-pipe venting to two-pipe venting.
