PRODUCTS: Dunkirk Boilers - Hotline Series Indirect Water Heater

Subject: Coil Change

Models Effected: HL-30, 40, 50, 80 & 119

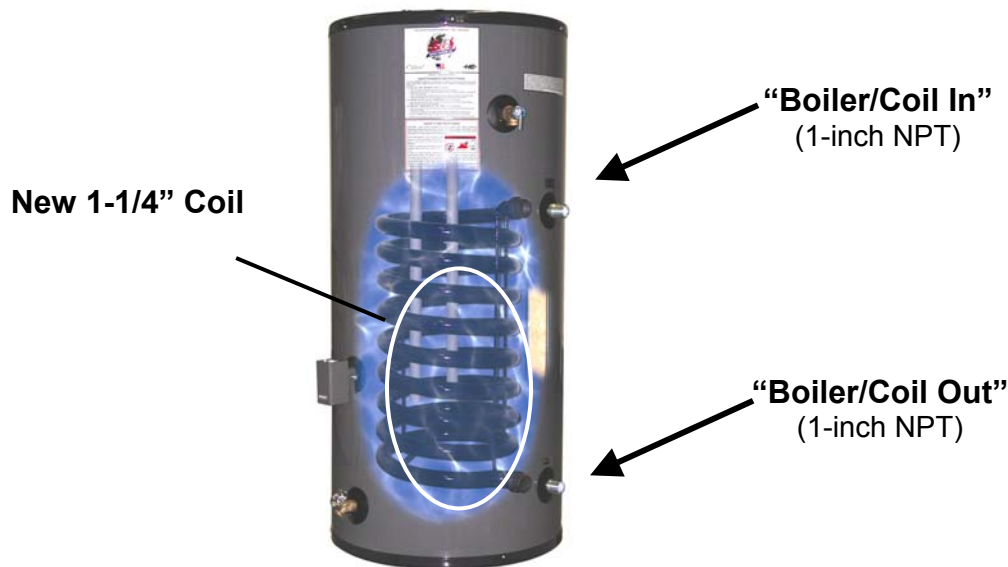
Effective immediately the HotLine Series Indirect Hot Water Heaters have changed as follows: (see illustration below)

- HL30, HL40 & HL50 have relocated their "boiler/coil in" and "boiler/coil out" tapings. Previously on the top, these connections are now on the side of the tank.
- All HotLine sizes (HL30 - HL119): Internal coil diameters have increased from 3/4" to 1-1/4". Coil connections for all sizes will now be 1-inch NPT.
